Boston's Open Space

1987
PARK EVALUATION
&
SITE SUMMARIES

EVALUATION OF
CITY OF BOSTON
PARK AND RECREATION LAND

NEIGHBORHOOD OF HYDE PARK

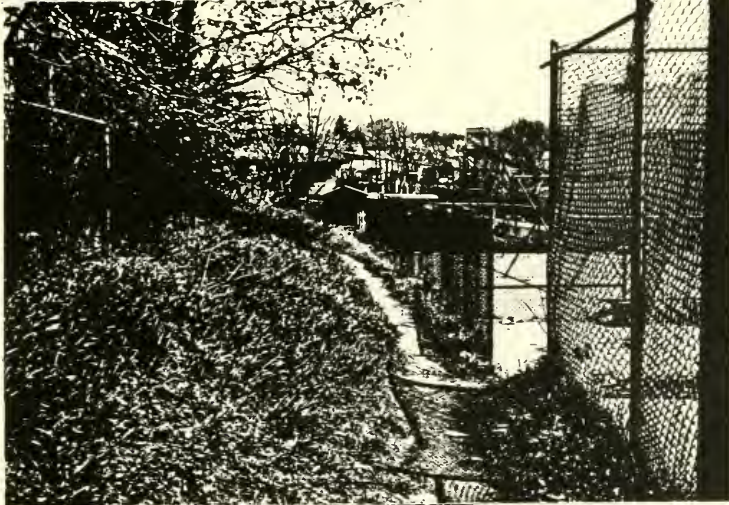
Site Photograph 1

Two chain link fences create wasted and difficult-to-maintain space. This shows short-cut desire line.

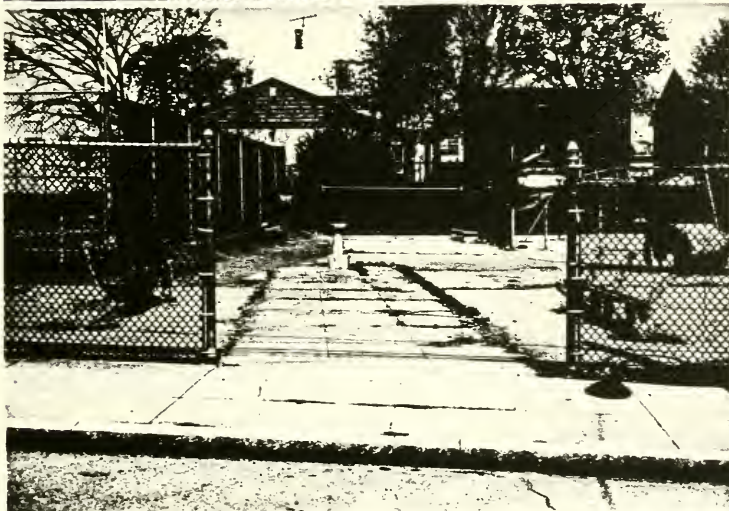
Site Photograph 2

Entrance into park showing destroyed benches, weed growth and trash. No trees or grass.

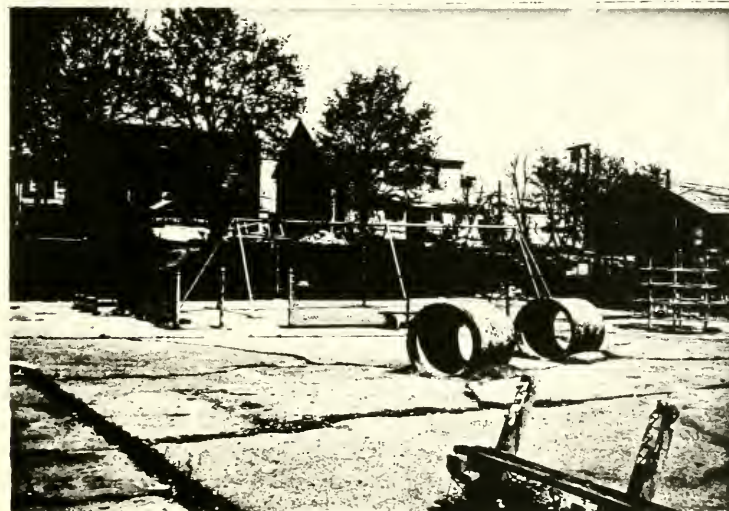
Site Photograph 3

Swings unusable, benches in need of repair, equipment needs painting.

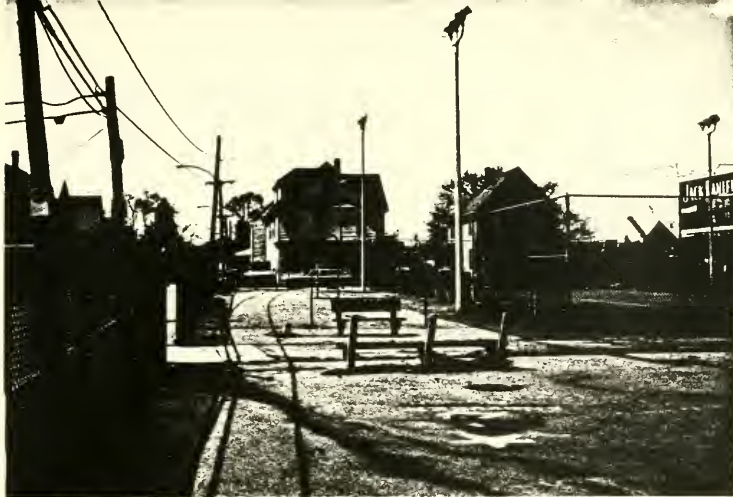
Site Photograph 4

Park lacks plantings -
excessive pavement

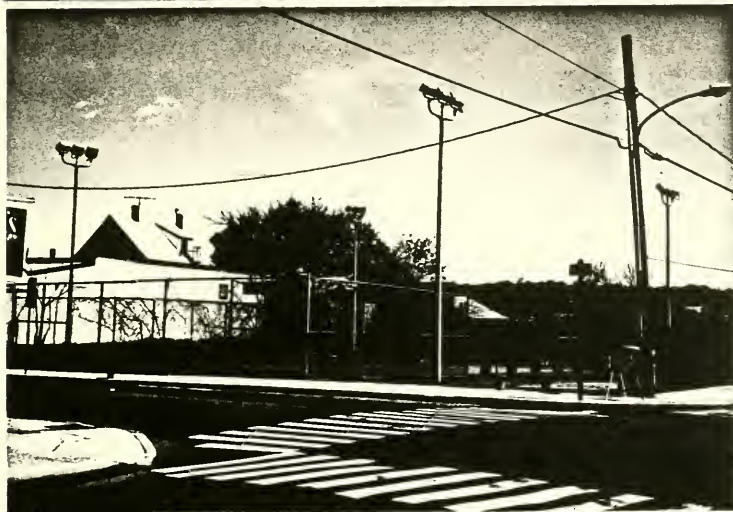
Site Photograph 5

View of park from
across street. Tennis
court recently converted
from basketball. Park
has bleak character.

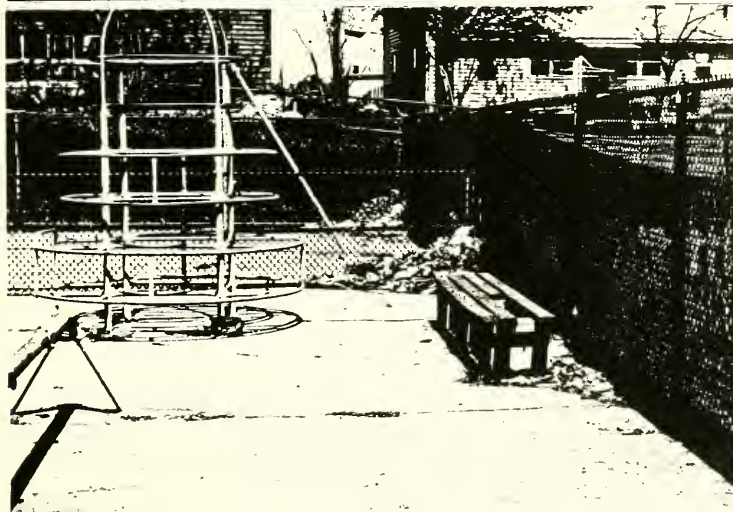
Site Photograph 6

Lack of maintenance -
trash and leaf build-up.

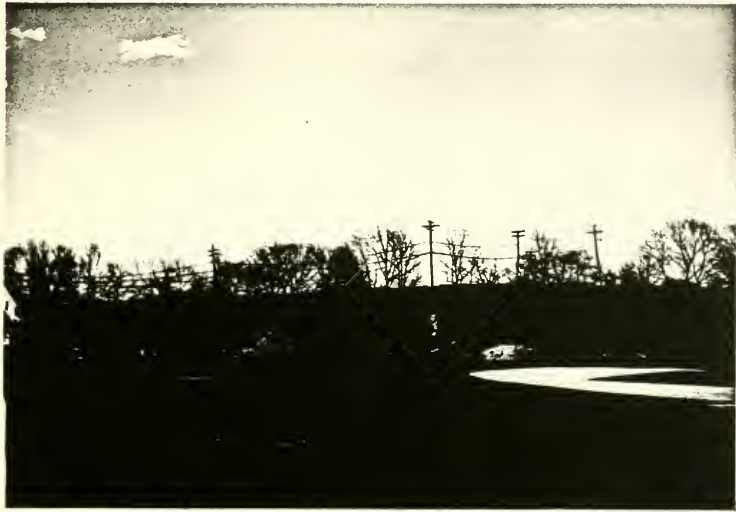
Site Photograph 2

Naturally wooded slope an asset to the site. Slope eroding in areas where pedestrians walk up and down.

Drainage and erosion appear to be major problems in several park areas, especially the slope below Milton Street. Foot traffic up and down the slope has caused major erosion gullies to form.

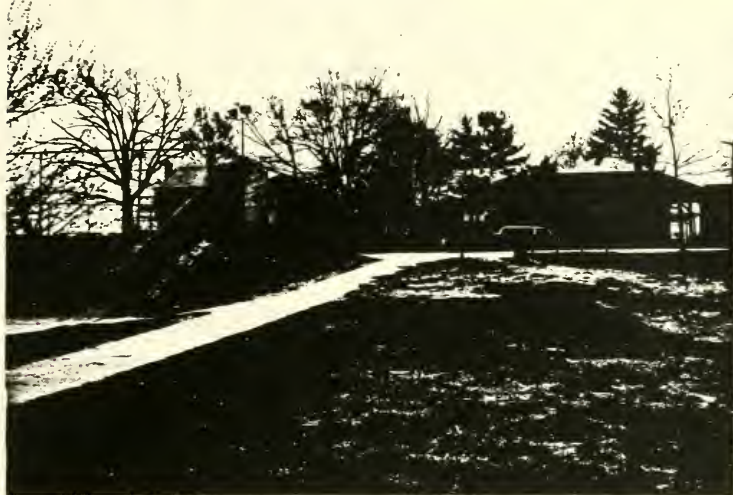
Site Photograph 4

Erosion problem - water sheet draining off basketball and tennis courts-eroding slope.

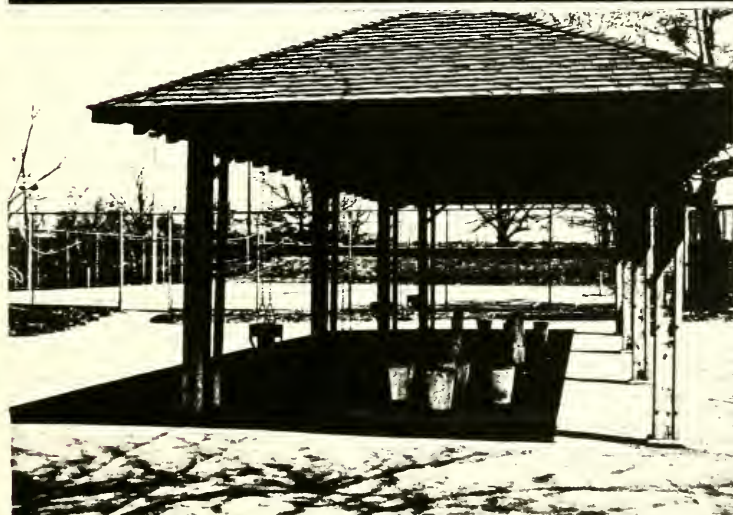
Site Photograph 6

New swings installed under shelter. Exposed concrete bases of picnic tables and game tables a safety hazard.

Only exposed footings and concrete bases remain from picnic and game tables that were under the open-air shelter. These should be removed and replaced with new tables.

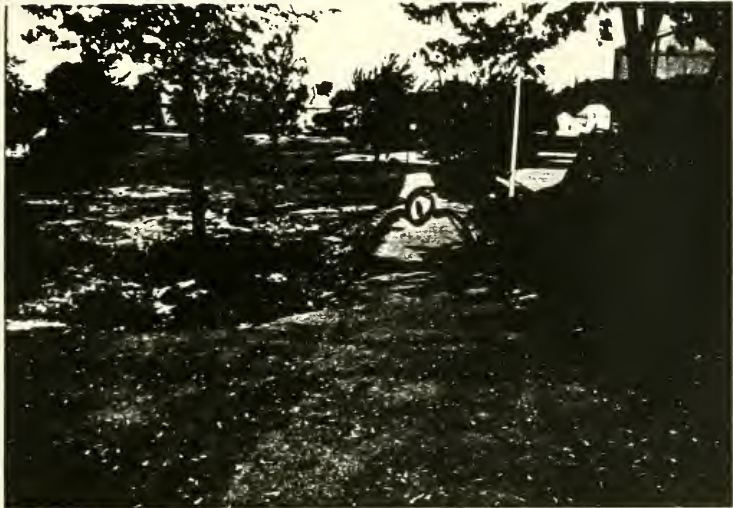
Site Photograph 7

1. Erosion caused by storm-water flow, thin topsoil, stressed vegetation.

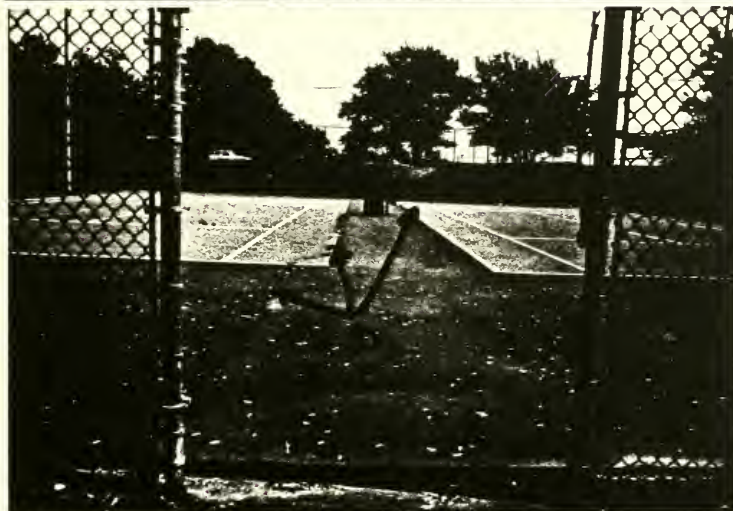
Site Photograph 8

1. Crack in tennis court--clean out, fill with cement or bituminous concrete and seal.

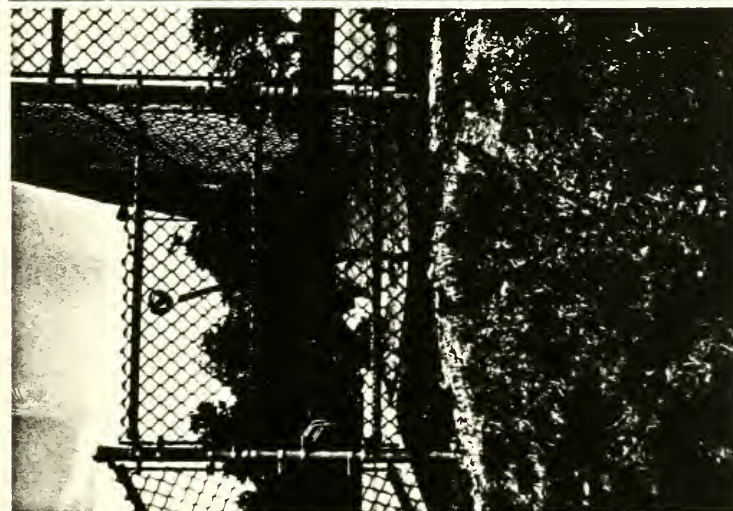
Site Photograph 9

1. Tennis court drainage swale.
2. Erosion due to thin topsoil, poor vegetation and stormwater.

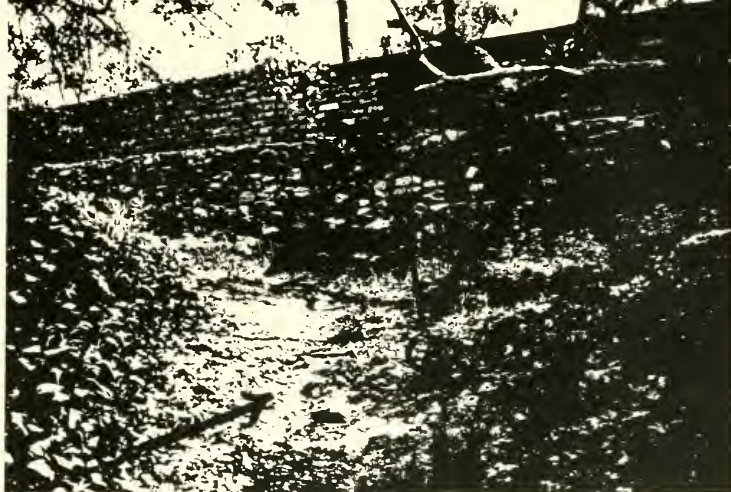
Site Photograph 10

1. Soil erosion due to pedestrian traffic, thin topsoil, poor vegetation and storm-water drainage.
2. Loose stone fill under Milton Street and Neponset Valley Parkway.

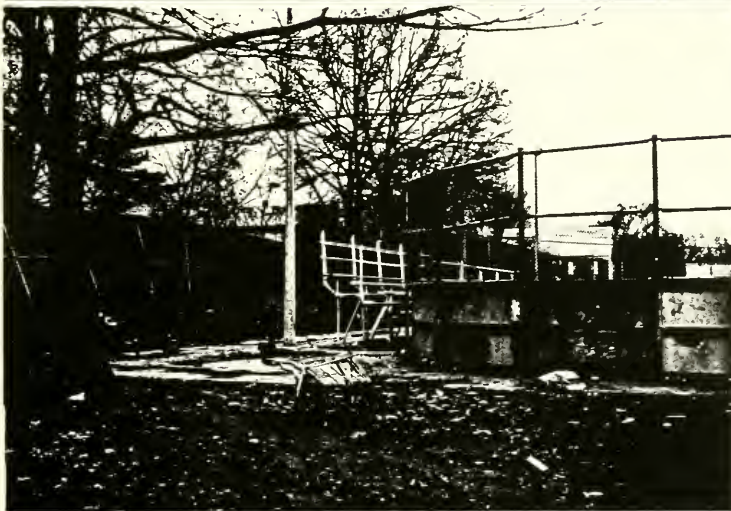
Site Photograph 3

One of numerous areas showing evidence of fire. Wall needs repair, trash needs removal.

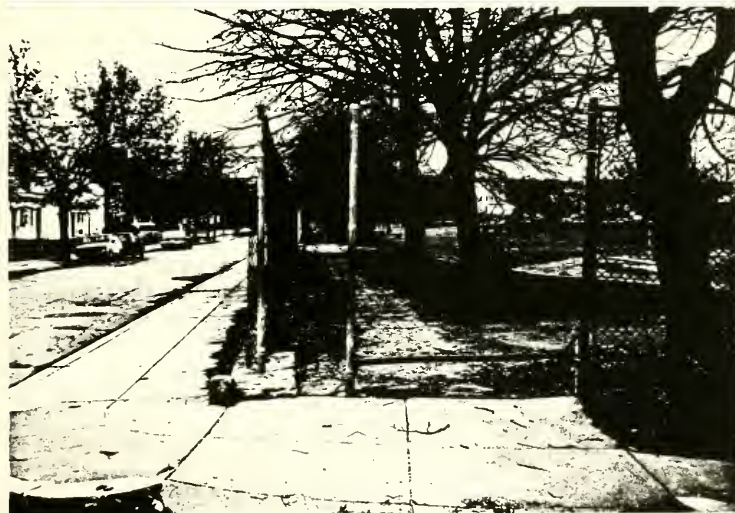
Site Photograph 9

Access points to park
need to be more inviting,
better defined.

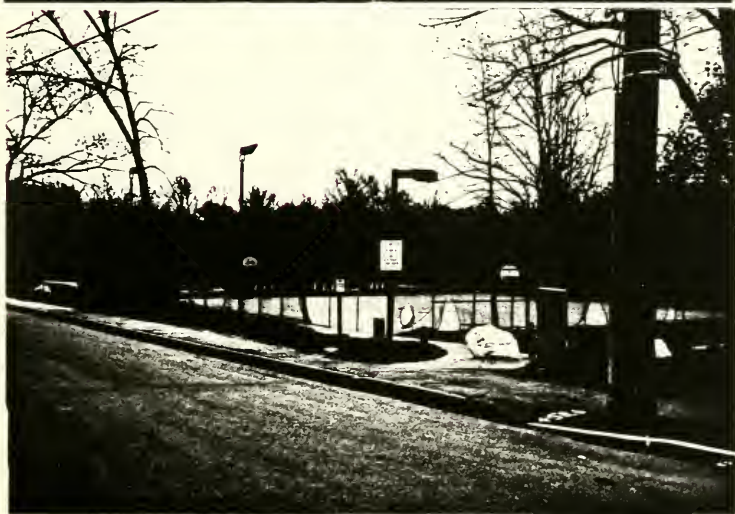
Site Photograph 3

Painted boulder used
for access control.
Fencing vandalised.

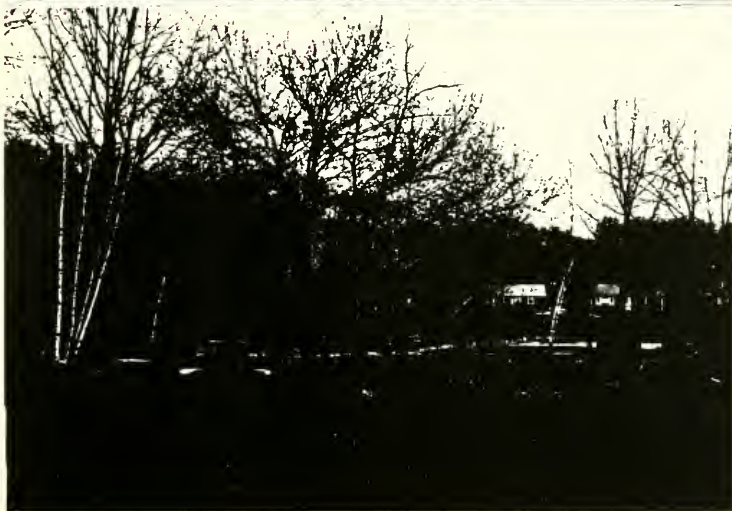
Site Photograph 6

Some tree pruning performed - brush not cleared up.

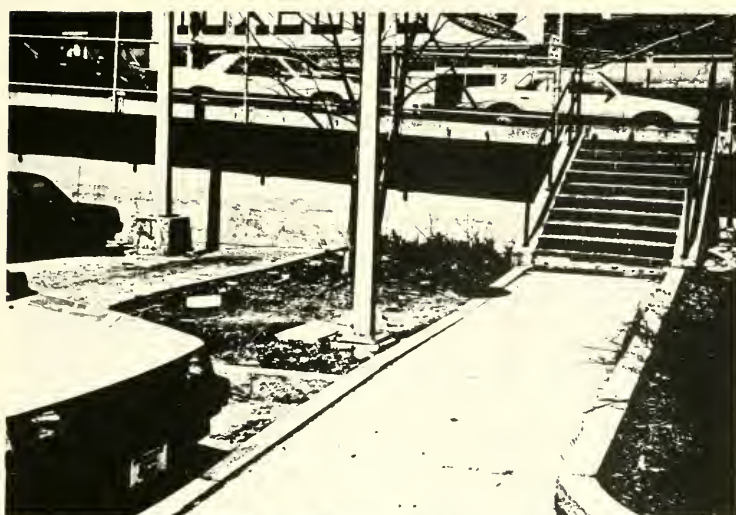
Site Photograph 1

Shows one set of brick-faced steps and spotty planting. Soil level too low on plant beds.

The soil seems to have subsided throughout the lower level. The sidewalk does not meet the bottom of the concrete steps nor does the soil meet the top of the curbs. Additional soil is needed. The bottom step of the brick-faced steps needs repair.

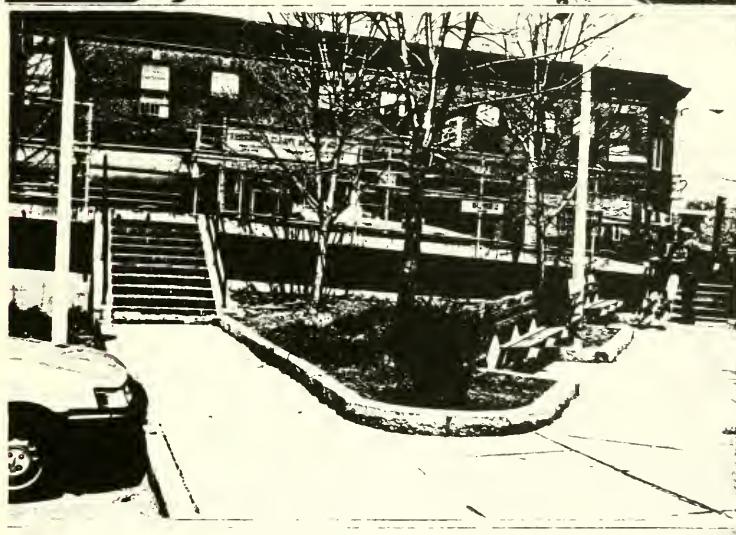
Site Photograph 2

Planting beds need weeding, mulching and additional planting.

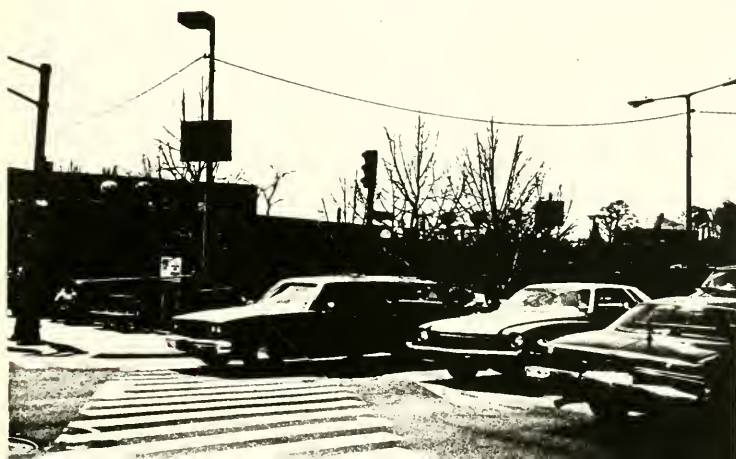
Site Photograph 3

Park not visible from street level. Sign not well located.

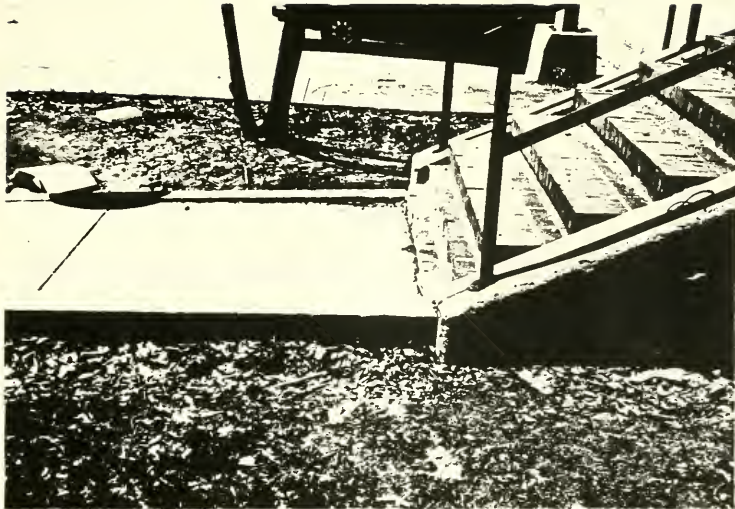
Site Photograph 4

Brick-faced steps -
Bottom step a safety
hazard.

The sidewalk, curbing, concrete stairs, railing and fencing are in good condition. The seating is mostly in fair condition. One light does not have a fixture. The trees are all in good condition, however the grass and shrubs are in poor condition. The bottom brick step is broken.

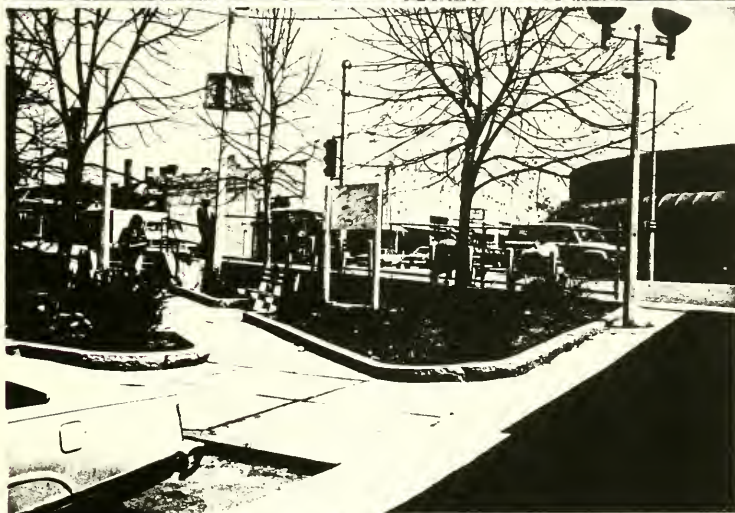
Site Photograph 5

Trash and weeds in
planting bed.

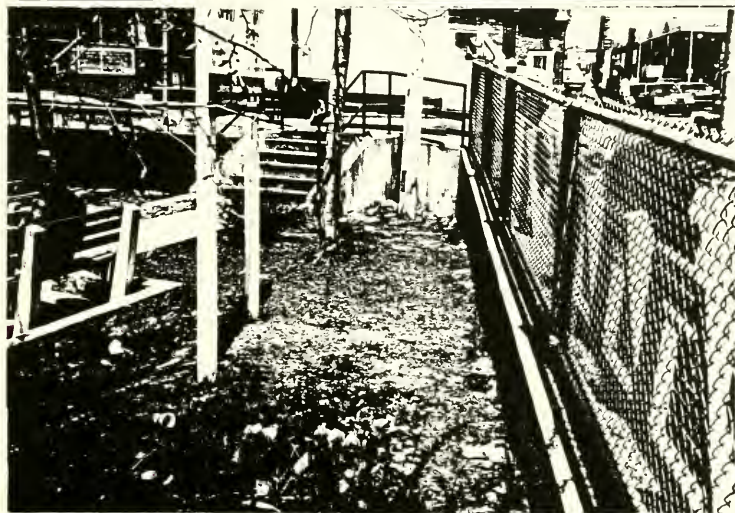
Site Photograph 6

Corner by steps traps
trash. Needs cleaning.

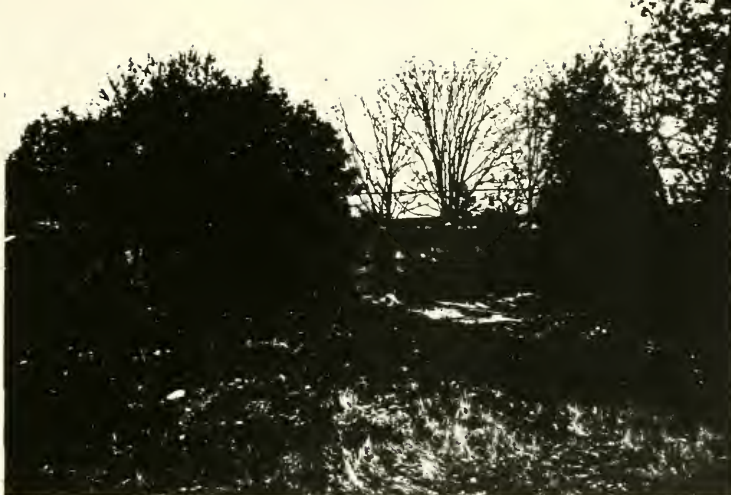
Site Photograph 7

Access way blocked by
dumped material.

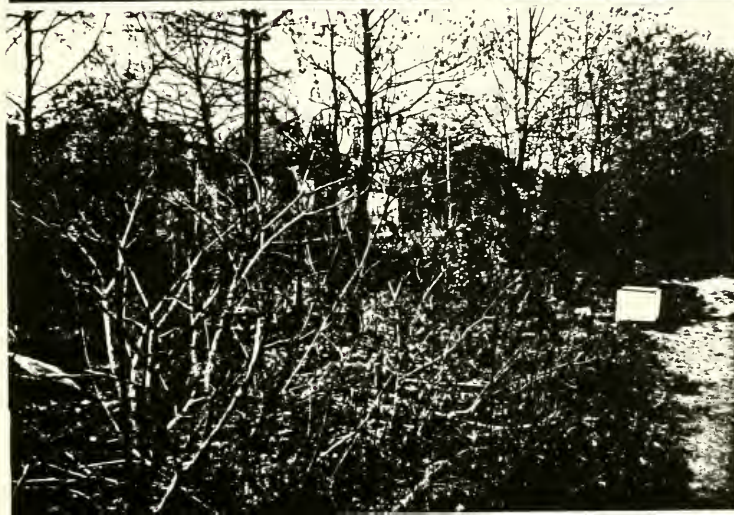
Site Photograph 3

Evidence of fire and
dumped trash.

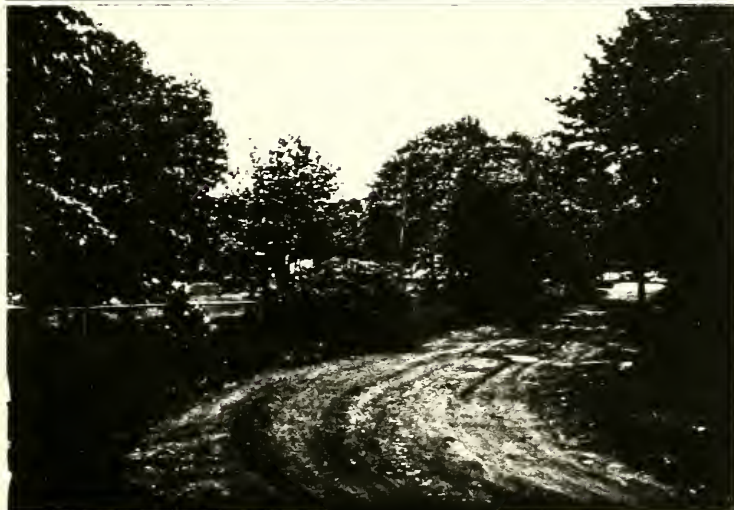
Site Photograph 6

Lakeside Avenue. No access through chain link fence.
